SAFETY ALERT

Structural failure and collapse of drill rig mast

Petroleum and Gas Inspectorate Safety Alert No. 41 25 June 2009

Drill Rig Walkway - Toe amputated when securing walkway

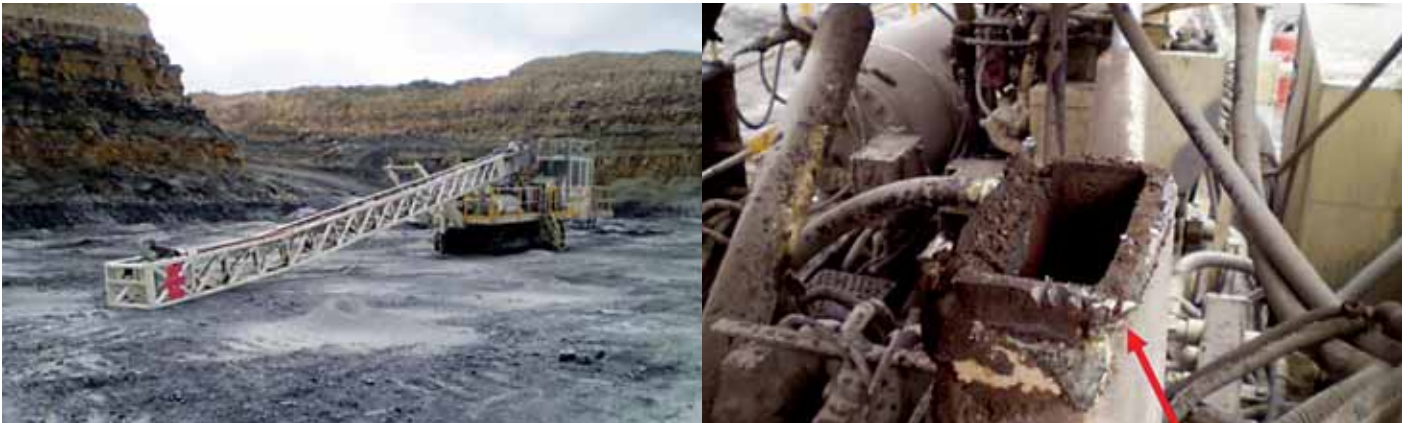
An onsite inspection concluded that the mast pivot points had failed where the bearing blocks were welded onto two RHS (rectangular hollow support) vertical supports. Further visual inspection of the drill rig identified additional cracking at the base of the bearing block support steel work.

The collapsed drill rig mast (left) and the drill rig's failed pivot point (right) on the RHS tubing.

1. Include, as part of the operator's pre-operational checks, a visual inspection of the mast pivot points, pivot shaft and supporting structure for any visual signs of cracking or component failure.

2. Include more detailed visual inspections on all critical elements as part of all periodic maintenance checks.
3. Consult with the plant original equipment manufacturer (OEM) about the frequency of non-destructive testing (NDT) of all critical structural elements to include, but not be limited to, mast pivot points, pivot shafts, locking devices and supporting structures.

5. Develop 'exclusion zones' around the plant whenever the mast is being raised or lowered before tramming or servicing.
6. Consult with the plant OEM to ensure the mast pivot points, pivot shaft and supporting structure are of the latest design. Should the plant require modification, this should be carried out in consultation with the plant OEM.

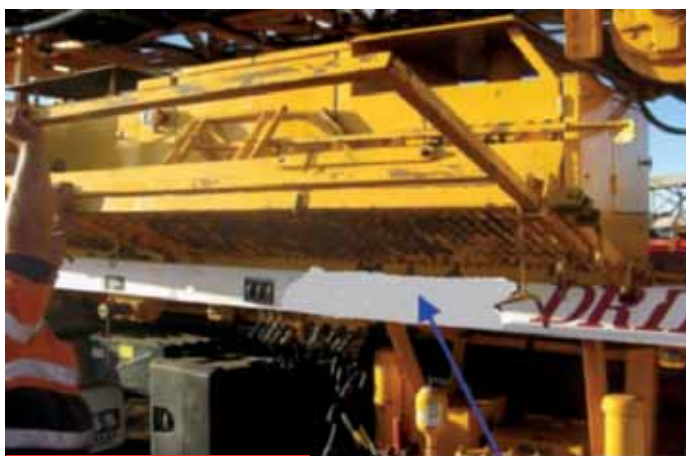
Fold down walkway

A person climbed part way onto a truck-mounted rig carrier vehicle to secure the fold down walkway on the side of the vehicle into the travel position.

A second person was standing on the ground beside the vehicle supporting the weight of the platform.

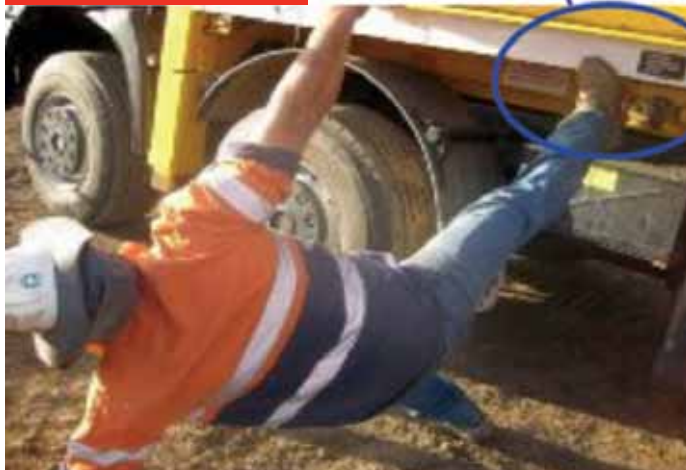
Re-enactment of event

The person on the vehicle lost his balance, and fell backwards whilst holding the walkway. His right foot was trapped between the walkway rail and edge of the tray on the vehicle.

As the platform hinged downwards, the end of the steel capped boot was severed by the guillotine action of the falling gate and fixed side rail on the vehicle. The person sustained two partially amputated toes due to this incident.

- Drilling companies must ensure that all hazards are identified in relation to their work activities, and appropriate controls are identified and implemented to reduce risk to as low as reasonably practicable.
- Hazards of this nature should be addressed by engineering controls and not rely on PPE (personal protective equipment) or administrative controls such as a job safety analysis to prevent injury.

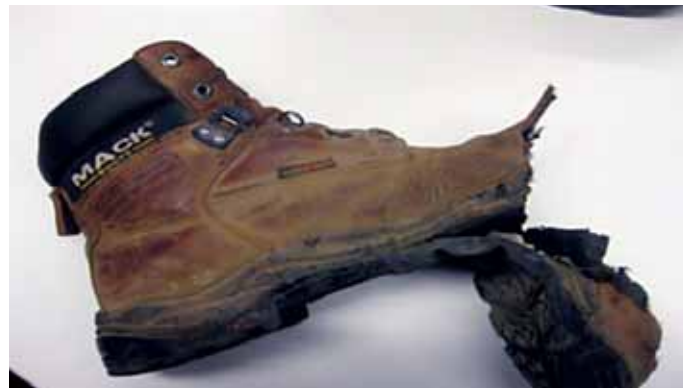
The person sustained two partially amputated toes due to this incident.
