# SAFETY ALERT

Petroleum and Gas Inspectorate Safety Alert No. 43 21 September 2009

## Broken leg from coal seam gas sampling incident involving high pressure.

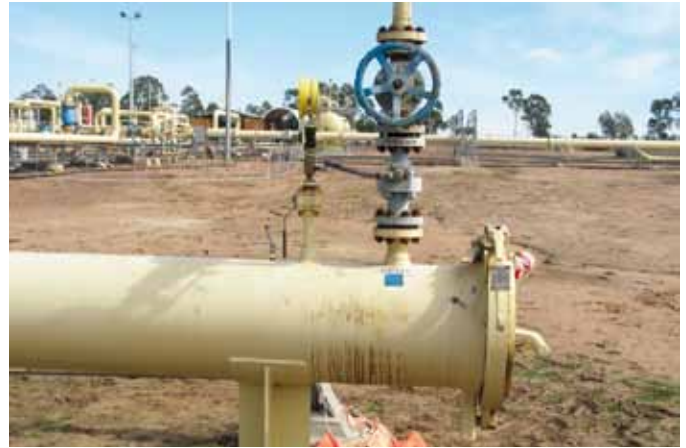
*Pig receiver and sampling point*

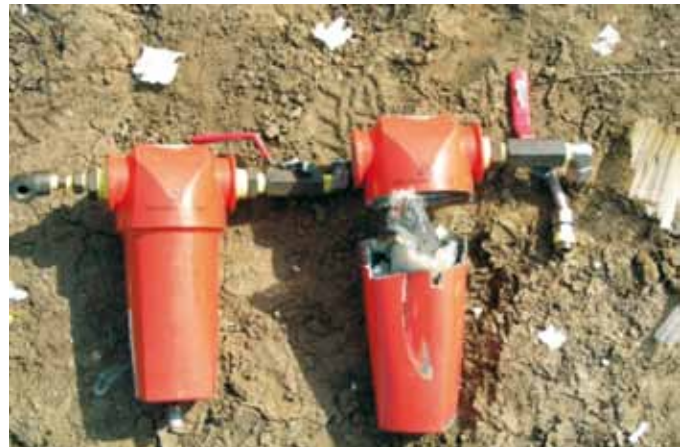
A gas sampling contractor was struck by a flying fragment from an exploded gas filter. The filter had been exposed to a pressure that exceeded its design specifications (1,600kPa). The filter was being used as part of a gas sampling kit on the high pressure (9,000kPa) product end of a coal seam gas processing plant. One of the contractor technicians undertaking the work sustained a broken leg and related soft tissue damage.

- Incorrect selection of filter type for the application.
- Contractors had no formal training in high pressure sampling and had not directly undertaken work before.
- Lack of risk assessment, identification of hazards and use of standard operating procedures when taking gas samples.
- Poor implementation and adherence to existing:
  - permit to work systems
  - company policies and procedures
  - contractor supervision

*Damaged Filter*

- Gas sampling connection and disconnection procedures to include requirements for correct sequence of events and specify the type and rating of components that form the sampling kit.
- Dedicated sampling point to be provided if regular sampling is a standard requirement at the facility.
- Organisations to immediately review their:
  - Hazard registers
  - Risk assessments
  - Standard operating procedures (SOPs)
  - Job safety analyses (JSAs)
  - Contractor training and supervision requirements.
